Manhole Inspection Summary

Manhole # S53G__016MH

Insp Date: **7/29/09 9:53 AM**

Location Address: **301 S CLINTON ST**

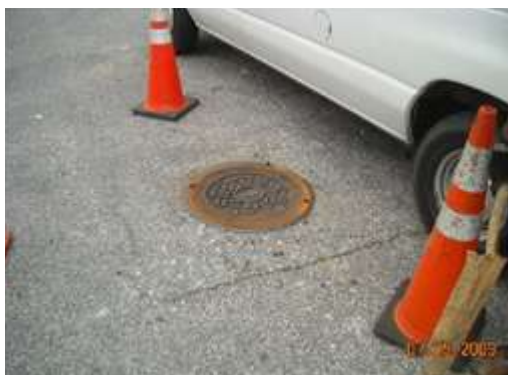
Miscellaneous

REPLACED BROKEN COVER WITH
WATER TIGHT LID

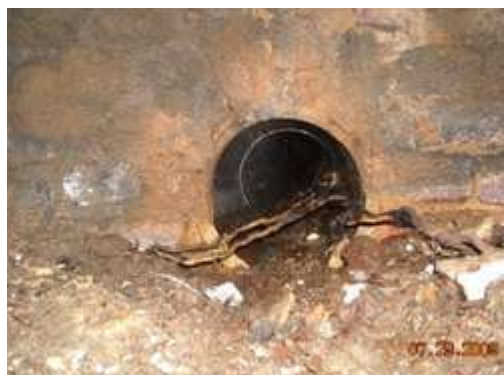
Defect 5

Condition: ☐ Sound ☐ Cracked ☒ **Root Intrusion** ☐ Deteriorated ☐ Leaks ☒ **Debris**

ROOTS IN TERMINAL CHANNEL
DEBRIS LEADING DOWN THE PIPE

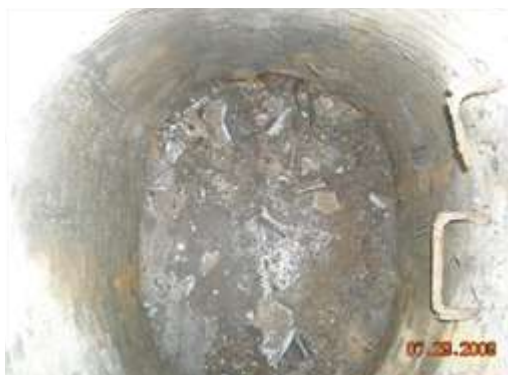
Defect 3

DEBRIS IN TERMINAL CHANNEL

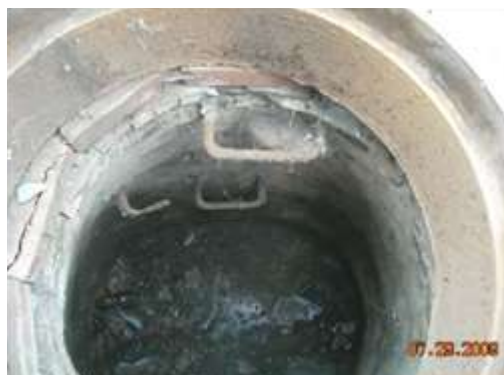
Defect 2

Count: **3** Missing: **2** ☒ **Corroded**

CORRODED AND MISSING STEPS

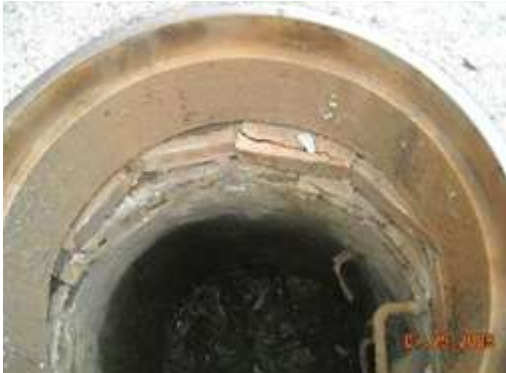
Defect 1

Offset: **3** (in.)

Condition: ☐ Sound ☒ **Cracked** ☐ Root Intrusion ☐ Loose Brick ☐ Deteriorated

CRACKED CHIMNEY BRICK; FRAME
OFFSET

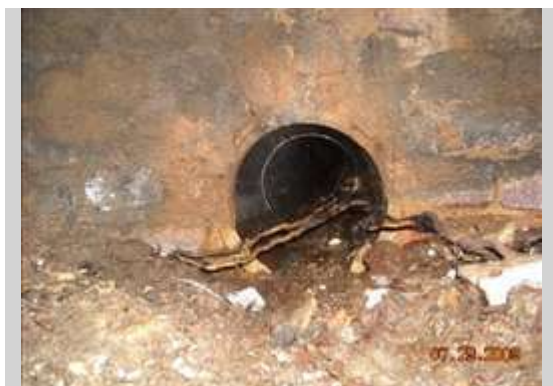
12 O'Clock Outflow

Deposits: ☐ None ☐ Mud ☐ Sludge ☒ **Debris** ☐ Grease

Silt Depth: **0** (in.) Deposits Extent: **Light**
